Expedient Road Construction Over Soft Soils

Rosa L. Santoni, Carroll J. Smith, Jeb S. Tingle, and Steve L. Webster May 2001

Final report

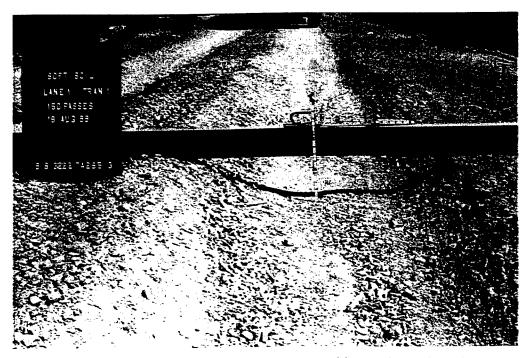
Photo 39. "T" anchors used to prevent fiberglass-reinforced mat movement

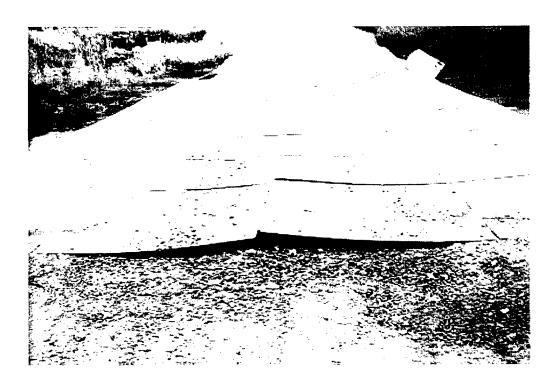
Also, at the 150-truck pass level, the geofoam/fiberglass mat system (Item 1) was considered unsafe. As the truck progressed across the roadway, a bow wave was noticed in front of the truck's front axle. The condition of the roadway system is shown in Photo 41. As shown, the center buoyant geofoam block was protruding upward since several of the connector pins were damaged and dislocated from the fiberglass mats (Photo 42). Twelve pins with plastic center plugs and seven with steel center plugs were dislocated. A close-up (Photo 43) of the roadway system shows that the center foam block was broken in two pieces, and other blocks on the same end were suspected to be broken. Repeated truck traffic had caused pumping beneath the foam blocks. Sand and subgrade material were forced toward the edges of the roadway, and the foam blocks along the roadway edges were tilted upward (Photo 44). Rutting of the roadway surface exceeded 3-in. (Photo 45).

Photo 41. Condition of Lane 1-Item 1 after 150 truck passes

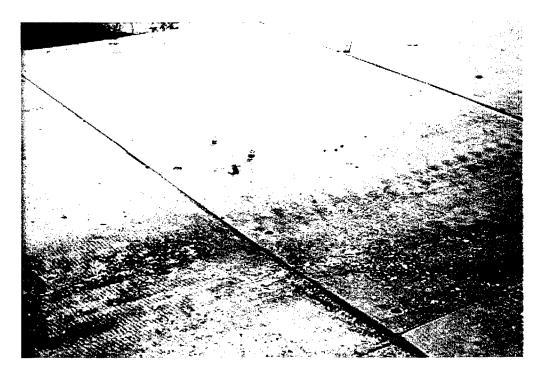
Photo 42. Dislocated connector pins on Lane 1-Item 1 after 150 truck passes

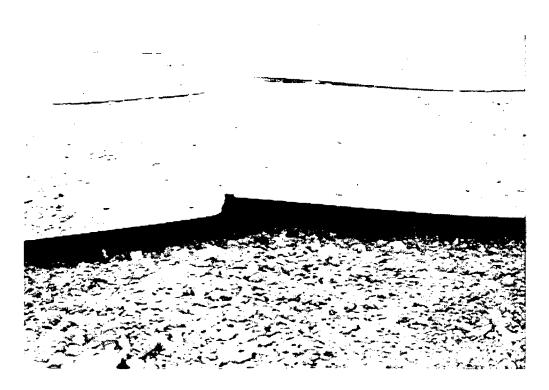
- Item 1. Item 1 reached a permanent deformation of 3 in. after 50 truck passes and completely failed after 150 truck passes as a result of pumping of fines from beneath the roadway, failure of the geofoam in bending, and dislocation of fiberglass mat connector pins because of excessive flexing of the mat. The mat itself performed well and no panels were damaged.

Photo 43. Close-up of broken center foam block, Lane 1-Item 1 after 150 truck passes

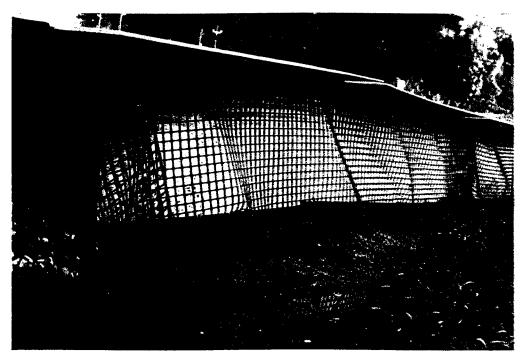
Photo 44. Condition of roadway edge, Lane 1-Item 1 after 150 truck passes

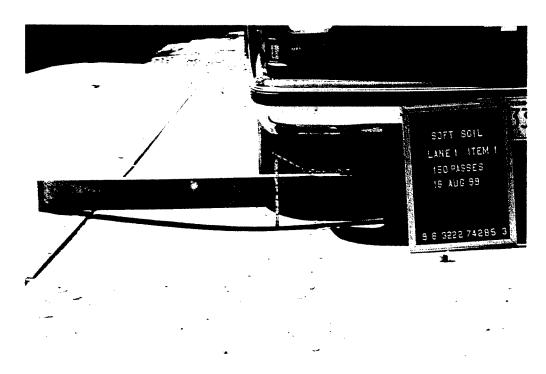
Photo 45. Rutting in excess of 3-in. on Lane 1-Item 1 after 150 truck passes

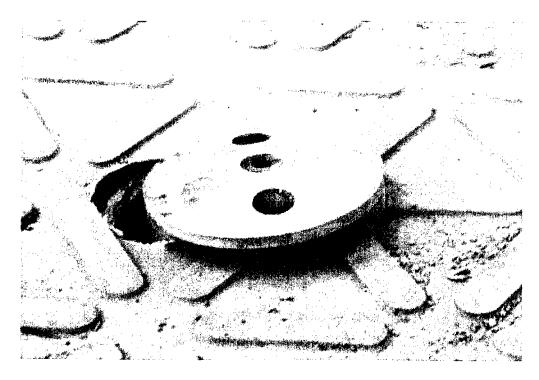
Maintenance was performed on Item 5 after 300 truck passes. A loose timber from a SOLOCO wood mat was nailed in position, and traffic was continued on the roadway. After 300 truck passes, two metal connector pins in Item 3, which connected the top layer of plastic DURA-BASE mats, had loosened. The shoulder of the pin came out of the mat slot (Photo 47). This

condition remained and did not affect the performance of the plastic mat for the remainder of the 2,000 truck passes.

Photo 47. Loosened connector pin on Lane 1-Item 3 after 300 truck passes

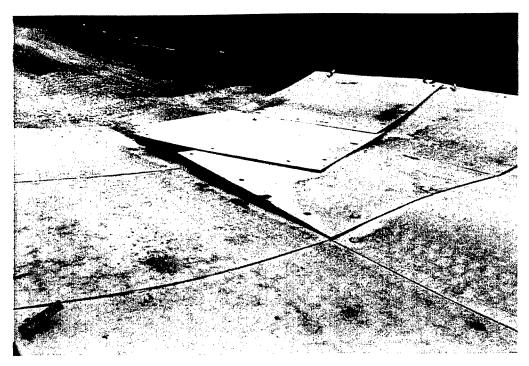
Continuous truck passes caused rutting to increase beneath the fiberglass mats in Items 3 and 4. After 300 truck passes, connector pins became dislocated on several fiberglass mats where Item 3 transitioned into Item 2, and the fiberglass panels were free to move as traffic continued. Nine connector pins with plastic center plugs and seven pins with steel center plugs were dislocated. The condition of the fiberglass roadway is shown in Photo 51. Also at the 300 truck pass level, four connector pins in Item 4 were dislocated (two pins contained plastic center plugs and two pins contained steel plugs). Since the permanent deformation was 3 in. and the connector pins were beginning to dislocate, the fiberglass mats were removed from Items 3 and 4. There was no evidence of damage to the fiberglass panels. Rutting exceeded 3 in. on Item 3 (fiber-reinforced sand) and Item 4 (sand) as shown in Photos 52 and 53; respectively. DCP measurements revealed that the average strengths of Item 3 and Item 4 were 17 CBR and 12 CBR; respectively.

Photo 51. Condition of Lane 2-Item 3 after 300 truck passes

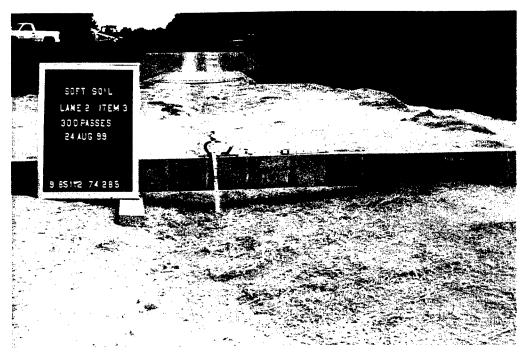
- Item 3. The thickness of the fiber stabilized sand layer was increased from the initial design thickness of 18 to 28 in. because of the weaker-than-expected subgrade strength encountered. This item failed with 3.1 in. of permanent deformation after only 300 truck passes. Failure was the result of inadequate thickness of the fiber stabilized sand layer. The thickness of this item should have been increased to adequately analyze the performance of this roadway system concept.

Photo 52. Rutting of fiber stabilized sand medium on Lane 2-Item 3 after 300 truck passes

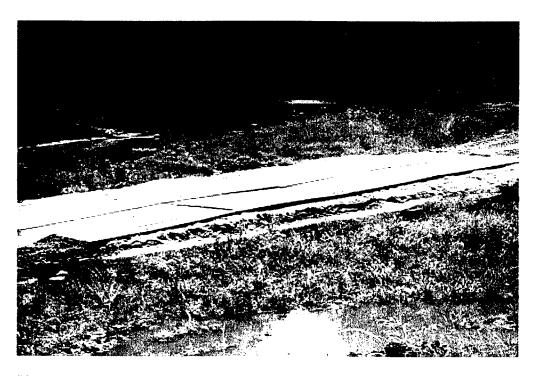
Photo 53. Rutting of sand medium on Lane 2-Item 4 after 300 truck passes

In order to continue traffic, the ruts in Items 3 and 4 were leveled, and a layer of Uni-Mat was utilized as roadway surfacing. The old Uni-Mat panels were placed with the 14-ft dimension parallel to traffic, and panels were installed two panels wide. Eight panels were placed in this manner to construct a 16-ft-wide roadway; however, an extra panel was placed with the 14-ft dimension transverse to traffic. The Uni-Mat panels were placed with a P&H crane. Photo 54 shows Items 3 and 4 after they were resurfaced with Uni-Mat and prior to resumption of traffic. Collection of data were discontinued on these two items.

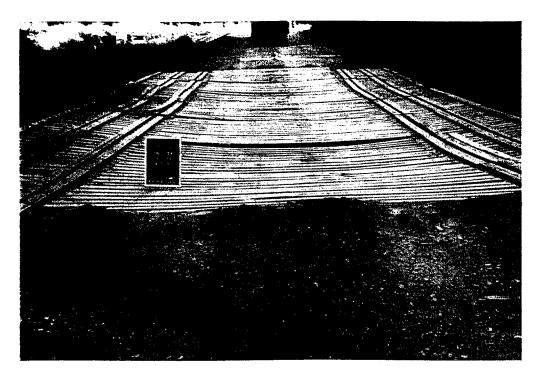
roadway. After 150 truck passes, the roadway was modified in order to continue traffic. During the 150 passes, maintenance of the fiberglass-reinforced mats included the replacement of 33 connector pins. The modified roadway system, Uni-Mat panels placed over the initial system, provided an adequate roadway for 1,850 truck passes. However, deformation measurements were extremely high and the roadway system floated. Photo 55 shows the posttraffic condition of the modified roadway. The roadway surface was concave shaped in both longitudinal and transverse directions. Most of the sand leveling layer beneath the blocks pumped to the edges of the roadway as illustrated in Photo 56. After all mats were removed from the geofoam medium, 11 of the 13 geofoam blocks along the center of the item were broken in two pieces (Photo 57). The geofoam blocks did not conform to the subgrade deformation and voids without breaking and failed in bending. Posttraffic DCP measurements revealed that the average subgrade strength was 0.1 CBR.

Photo 55. Posttraffic condition of Lane 1-Item 1 after 1,850 truck passes

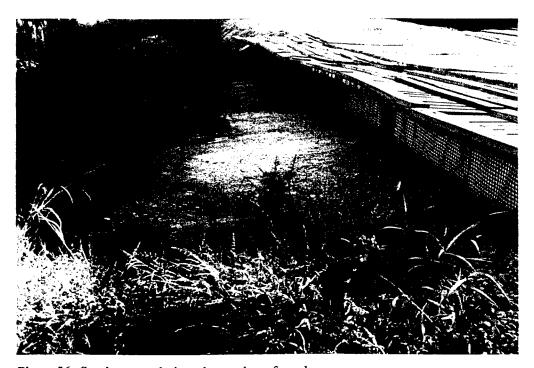
Photo 56. Sand accumulation along edge of roadway

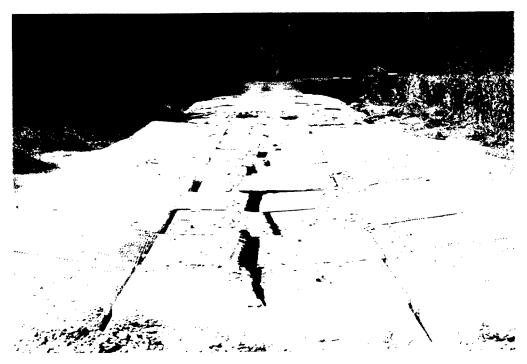
Photo 57. Posttraffic condition of geofoam blocks, Lane 1-Item 1

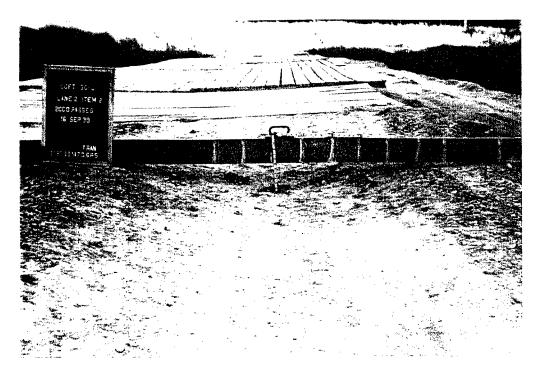
Lane 2-Item 2. Photo 62 illustrates the post traffic condition of the roadway system (limestone surfacing placed on ECM material and geotextile) after 2,000 truck passes. Permanent deformation exceeded 3.5 in. after 150 truck passes, and deformation continued to increase as additional traffic was applied.

Photo 62. Posttraffic condition of Lane 2-Item 2 after 2,000 truck passes
